Four IPS e.max CAD single crowns – Teeth 12-22, in 4 hours

Case Description

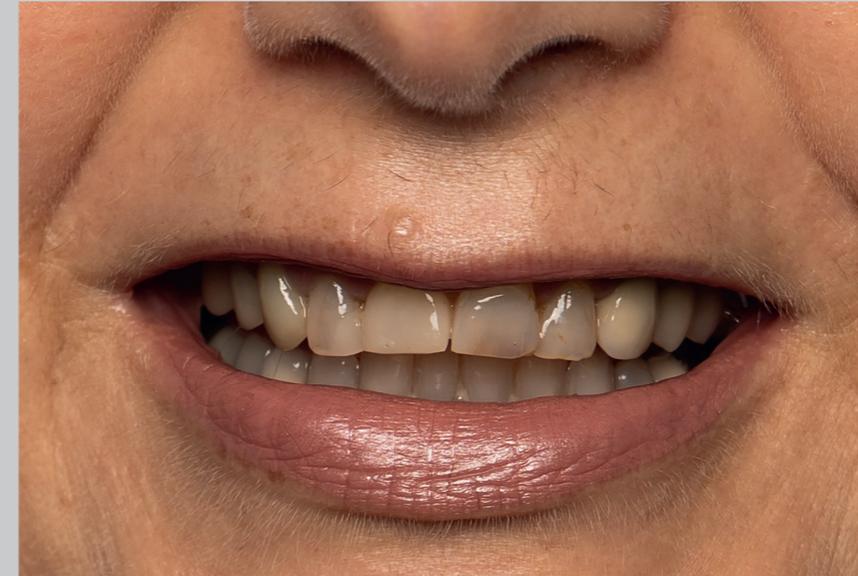
Before:

Inadequate fillings on teeth 12-22, an uneven gingival line on 12-11 and incisal edges severely eroded.

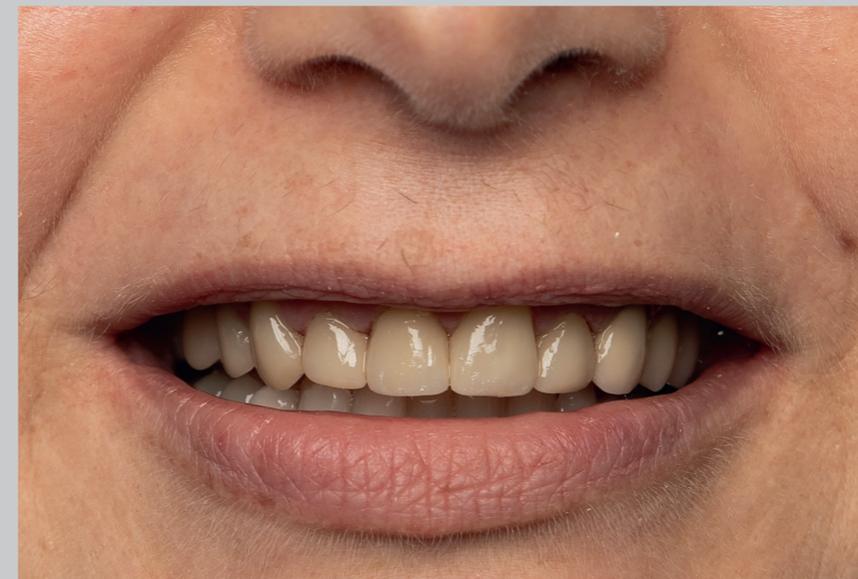
After:

Four highly esthetic and individualized lithium disilicate ceramic crowns.

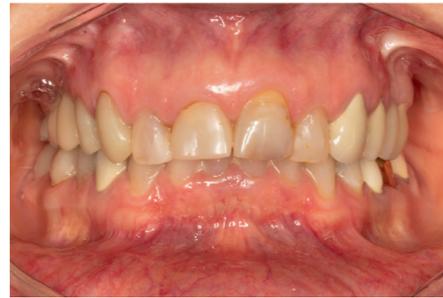
Insufficient fillings in the upper front and abraded incisal edges. The crowns 23-26 were made several years ago alieno loco and should be replaced with the next procedure.

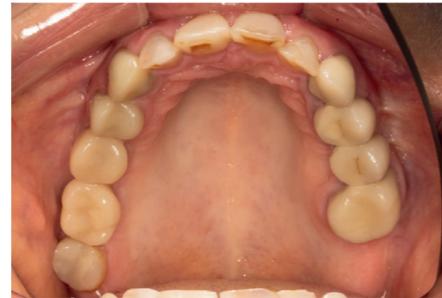
Also from palatal the teeth 12-22 had a secure distraction.

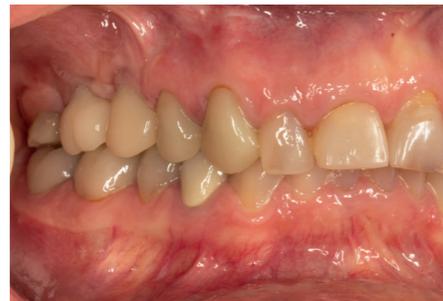
The irregular line of the gingival margin.

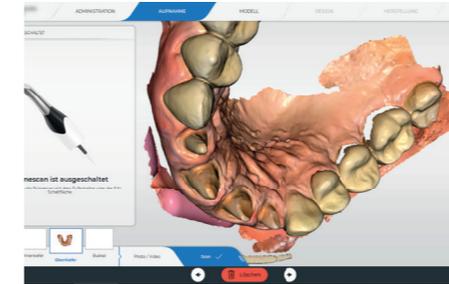
The scan of the upper prepared jaw.

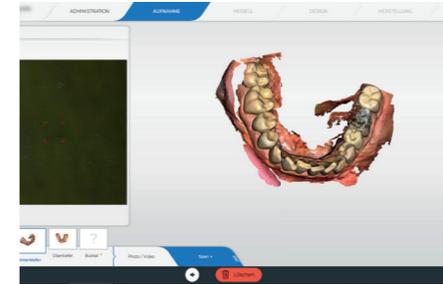
The scan of the lower jaw.

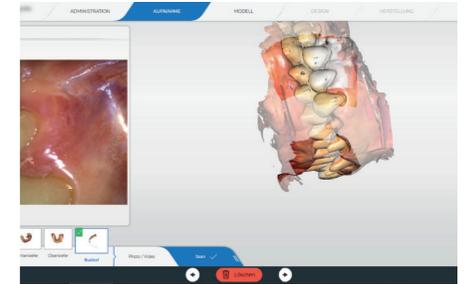
Buccal occlusion.

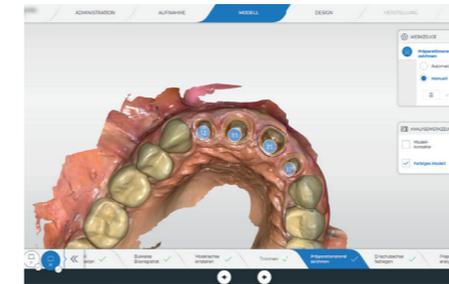
The system showed a perfect preparation line.

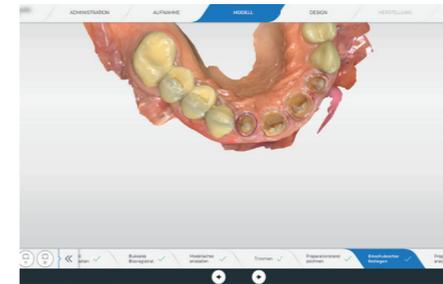
Only minimal corrections of the preparation line were made.

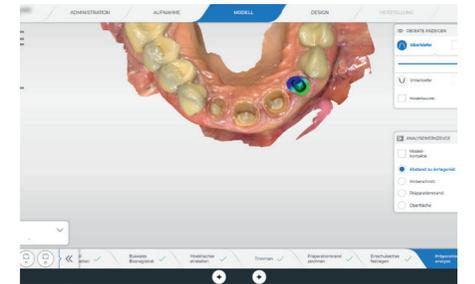
Preparation analysis to identify potentially problematic areas. In this case there were none.

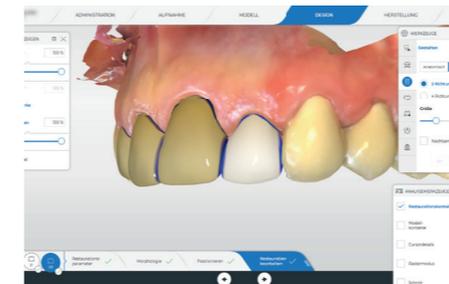
The construction from the labial side.

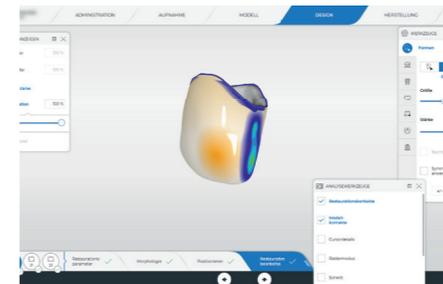
The design of the proximal contact point.
